U.S. COAST GUARD
MARINE SAFETY OFFICE PORTLAND, MAINE

SAFETY ALERT

Small Vessel Stability Warning

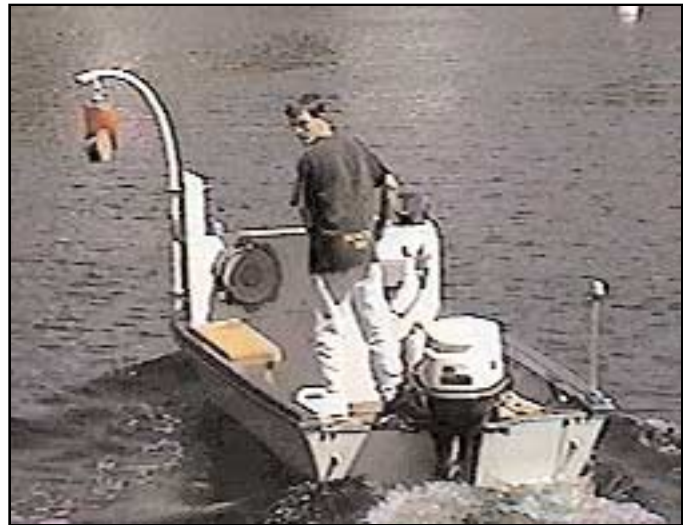
An examination of the skiff following salvage found that the vessel's propeller had been fouled by line from one of the youth's traps. Coast Guard investigators believe the boat was swamped while the youth was leaning over the transom of the boat to clear the propeller. The boat, which was built before requirements for inherent buoyancy and level flotation, sank quickly after capsize.

This small skiff utilized for commercial fishing swamped while the operator was attempting to clear trap line which had fouled the vessel's propeller. Built before regulations which required inherent buoyancy and level flotation, the vessel quickly sank.

Unexpected rough weather, gear hung down on the sea bed, propellers fouled with trap line are examples of conditions which may be encountered during fishing operations. Vessels used for commercial fishing must be able to withstand these conditions without risk of capsize, swamping or sinking.

All vessels utilized for commercial fishing, including skiffs, are considered commercial fishing vessels and are required to comply with commercial fishing safety regulations, including life jacket, signaling equipment and regulations prohibiting vessels from operating in a manner which creates an especially hazardous condition.
